## RESERVE STUDY Level I, Full Study

### PINECREST SWIM & TENNIS CLUB

**Herndon, Virginia**

**October 10, 2012**

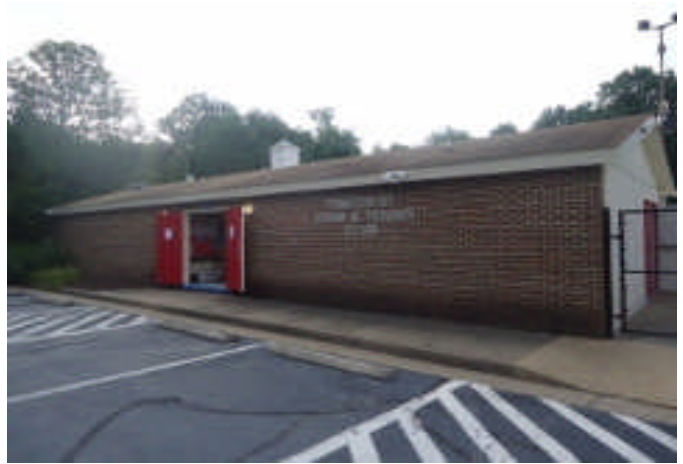
Front view of the building that houses the bathrooms, lifeguard room, and pool equipment.

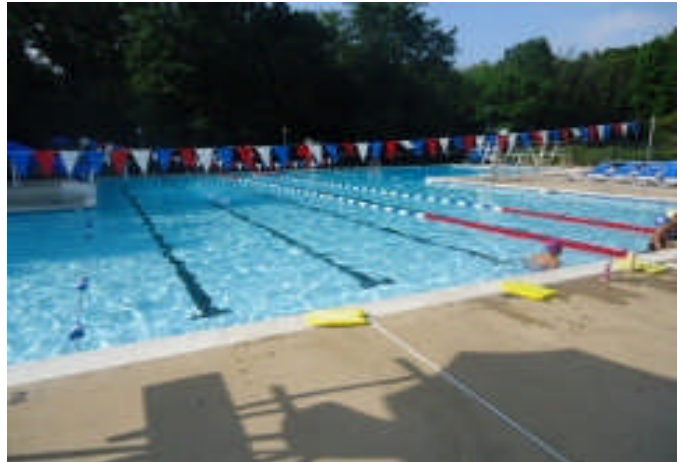
The club has two swimming pools. The larger pool contains 5985 square feet.....

We budget a reasonable amount at every other whitecoating cycle to correct minor problems usually found in the pool shell. Major catastrophic repairs caused by high water table flotation or major wall/floor failures are not budgeted for in the reserves because this work is not predictable. If failures do occur they are sometimes covered by insurance, if not, repairs may need to be funded from other sources at that time.

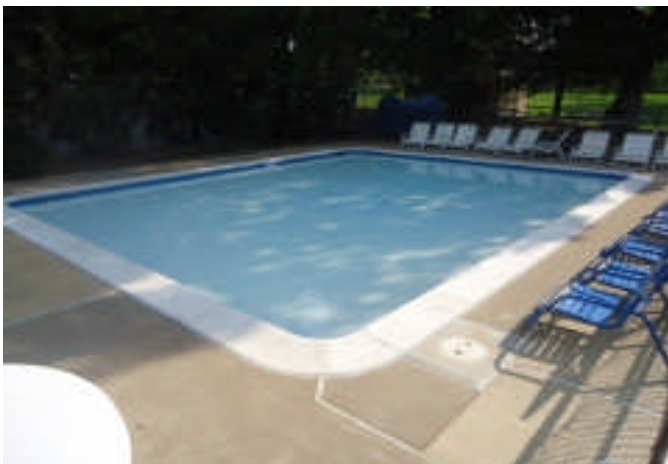
.....The wading pool is a 300 square foot facility.

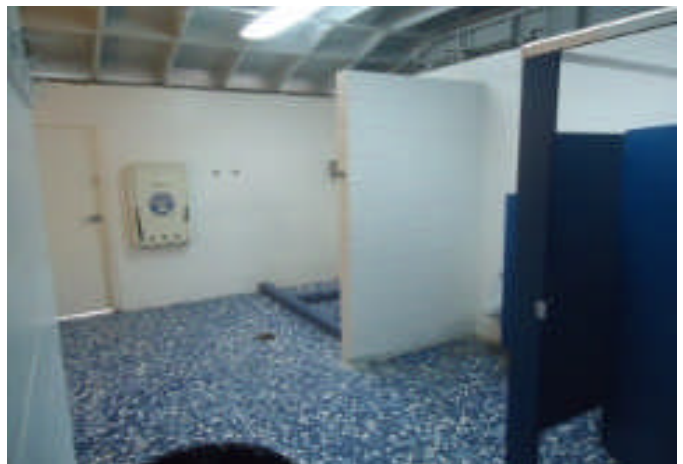
Bathrooms are in fair condition, but we assume they will need a future upgrade.

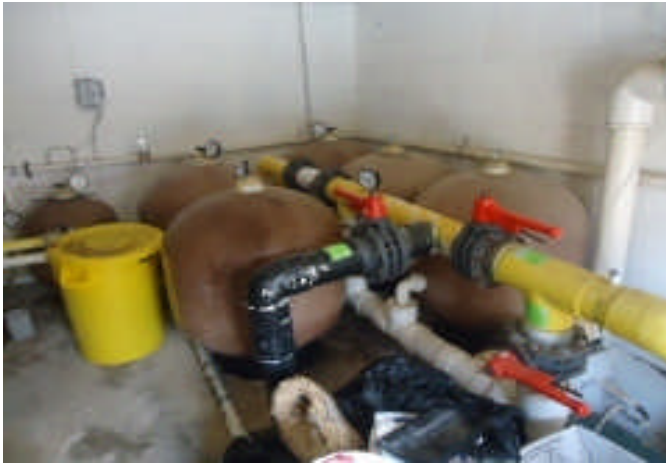
Pool filtration system that serves both pools.

Allows for filter replacement and usually encountered pump and water line problems.

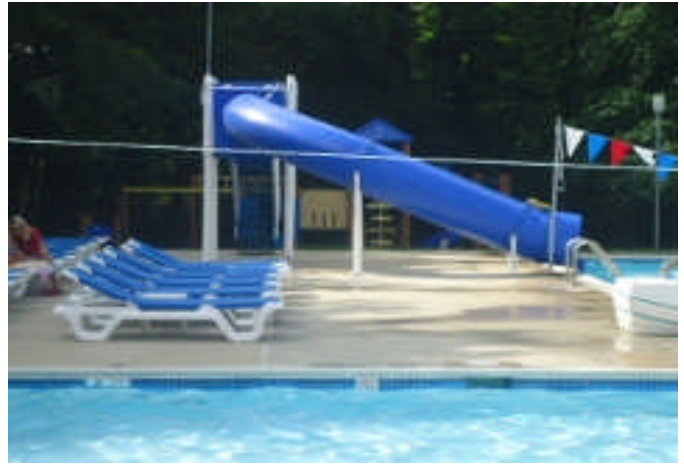
Water slide will eventually need to be replaced. We reserve for its replacement.

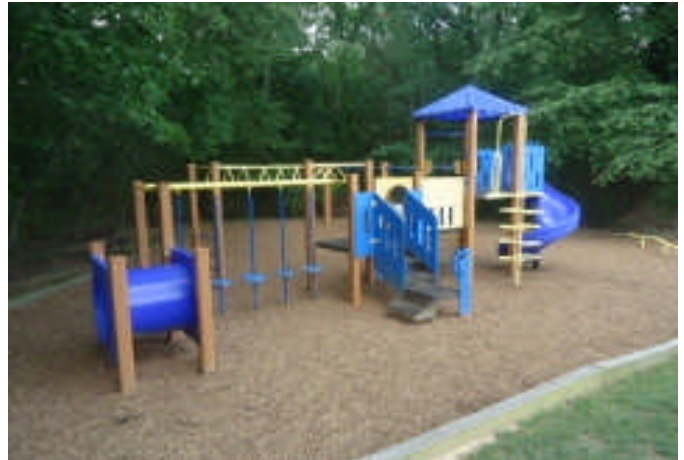
Tot lot is a metal and plastic unit that should achieve a useful life of at least 25 years.

Metal and plastic unit is in good condition. To extend useful life of the equipment repair components as needed, i.e., periodically check nuts, bolts and other fasteners to assure they are holding the components properly. Keep the running surface filled with "loose fill materials" to absorb the shock when children fall or jump. Children falling on non-absorbing materials cause 70% of tot-lot injuries.

TOT LOT(S)	Tot-lot replacements costs can vary greatly - we use an average cost. To extend useful life of the equipment repair components as needed, i.e., protectively coat metal surfaces to prevent deterioration/corrosion, periodically check nuts, bolts and other fasteners to assure they are holding the components properly. Keep the running surface filled with "loose fill materials" to absorb the shock when children fall or jump. Children falling on non-absorbing materials cause 70% of tot-lot injuries.
------------	--

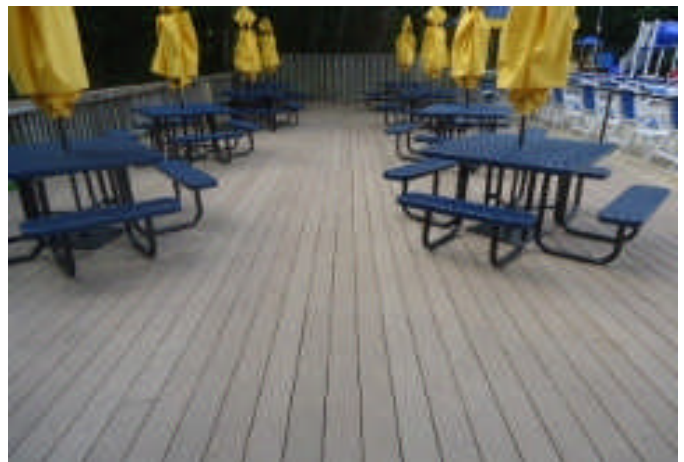
A sun deck is available adjacent to the pool. Decking is composite material. Composite material has a longer useful life than wood and requires far less maintenance than natural wood.

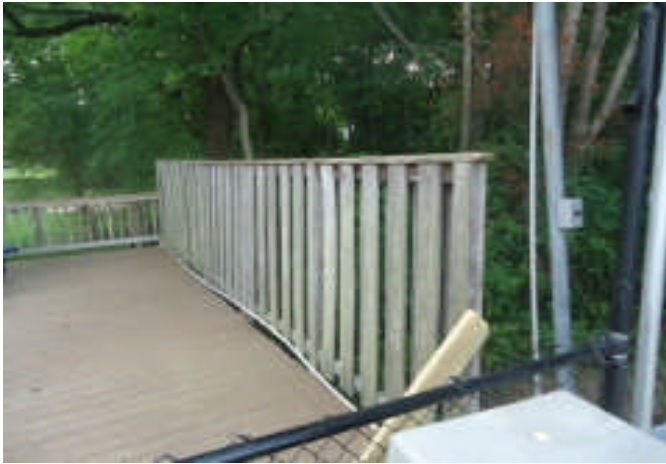
Board on board fence on one end of the sun deck is in fair condition.

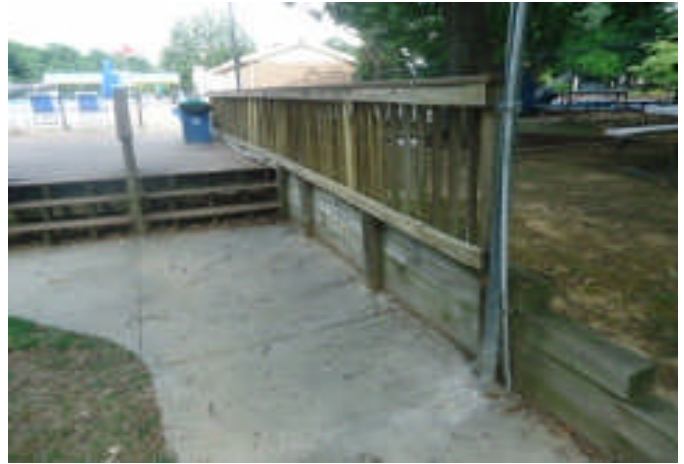
We also reserve for the wood retaining wall and railing that is placed on and near the sun deck.

WOOD RETAINING WALLS	Wood retaining walls typically have accelerated deterioration in the top member of the wall. In some cases these members can be replaced without replacing the entire wall. When total replacement is needed, consider installing a modular block system. These systems have a longer useful life and require less maintenance.
6' BOARD FENCE (PERIMETER)	We saw leaning post and loose boards. Spot repairs to loose members, straightening posts and applying a preservative or paint can extend useful life.
CHAIN LINK FENCE (PERIMETER AND POOL)	Fence useful life can be extended by painting to control rust, stretching fabric, straightening posts and adding tie wires to hold the fabric tight, when needed.

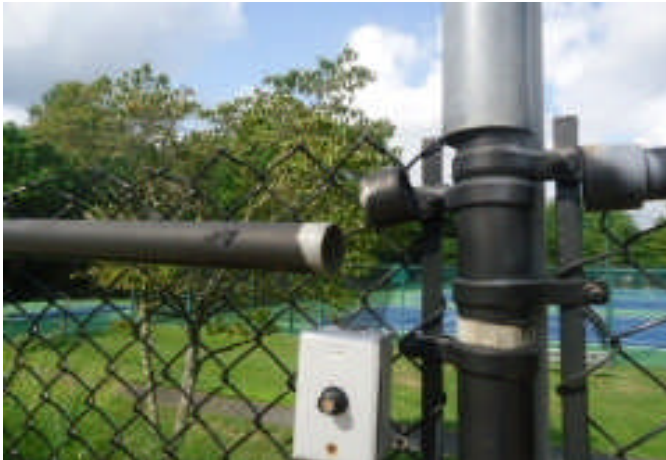
General maintenance consisting of spot repairs to rails and fence and tying up loose areas will extend the overall useful life of the fence.

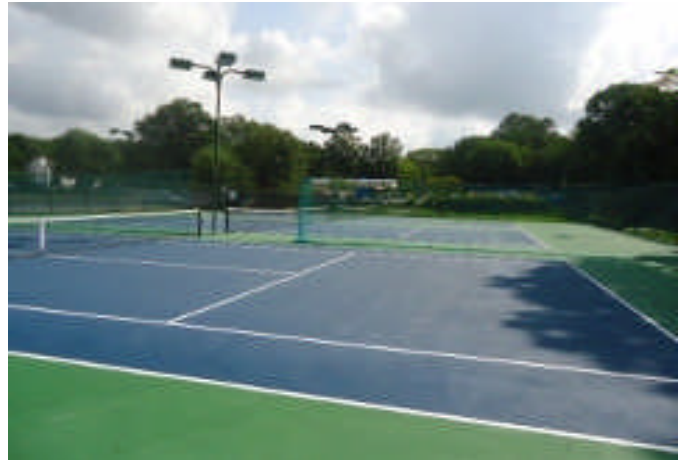
The club has three tennis courts. These courts were recently repaired and color coated.

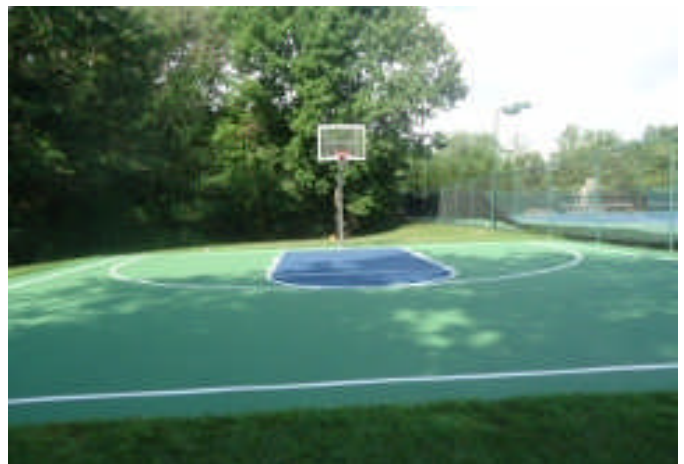
There is also one multi-purpose court with a basketball standard. Likewise, this court was recently repaired and color coated.

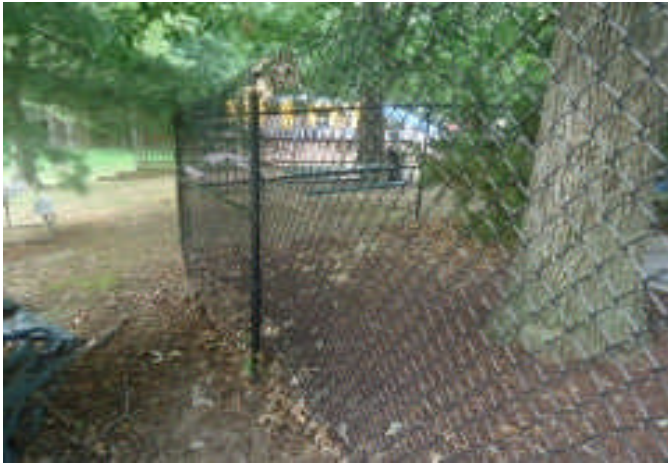
The property and swimming pool are enclosed by fencing. Fence consists of both chain link and board on board.

Fence useful life can be extended by painting to control rust, stretching fabric, straightening posts and adding tie wires to hold the fabric tight, when needed.

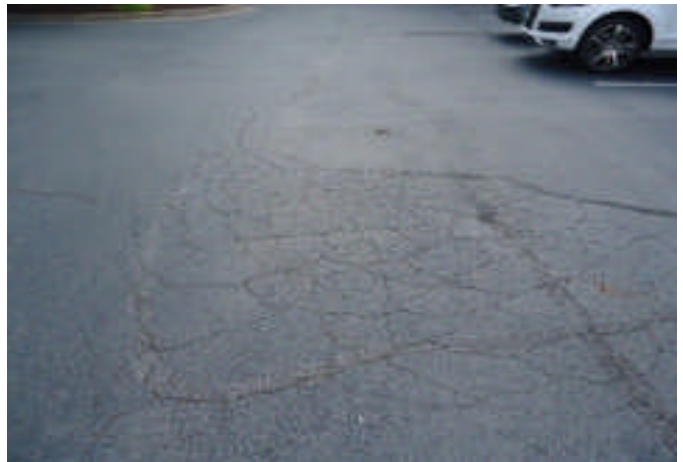
The lot is showing wearing surface and perhaps base failures. We assume the association will find it necessary to overlay the lot in about three years.

1) Implement a preventive maintenance program - preventive maintenance consist of sealing open cracks (equal to or greater than 1/8"), repair wearing surface/base/sub-base areas that have failed (distinguished by "alligator" or "chicken wire" cracking), applying a seal coat to the entire surface and repaint all traffic markings. An additional benefit of the seal coat and traffic markings is the pavement will look uniform and that enhances property appearance. Funding for this work is identified as "Preventive Maintenance" in the reserve table. Although we allow for this work to be done every four years, if cracks open or asphalt failures occur sooner they should be repaired at that time. The contingency built into the funding plan should be more than adequate to fund these repairs in the off years. If additional funds are needed in the scheduled years, likewise, the contingency should be used.

2) Be prepared to repave all asphalt around the time period shown in the table. Although we allow for 100% of the asphalt to be repaved our experience supports a smaller percentage of the base/sub-base will need repairs. We show that percentage in the "Base Course/Concrete Repairs" entry. When repaving, there are two possible courses of action; 1) mill only near the gutter pans to preserve proper drainage and then place a 1-1/2" of compacted asphalt throughout, and 2) total milling of all the asphalt and repave to the thickness removed. Also reserves for major concrete repairs to curbs, gutters and sidewalks.

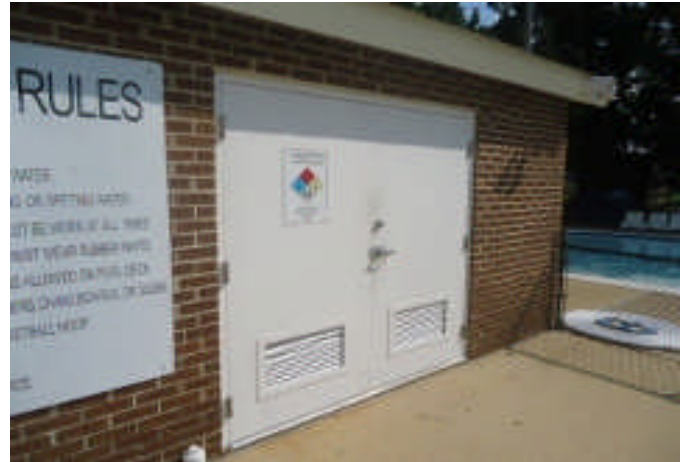
The pool equipment room door was recently replaced. We reserve for the remaining doors to be replaced when needed.

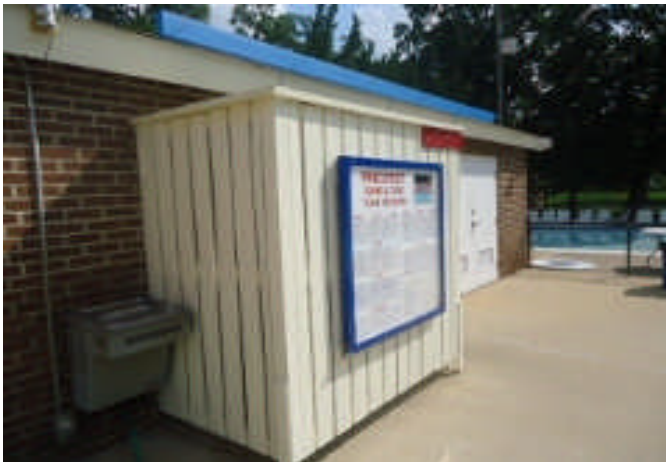
Small section of fencing outside both the men's and ladies' room is in good condition at this time.
